PROSTHODONTICS

Lec: 9

REPAIRS AND ADDITIONS TO REMOVABLE PARTIAL DENTURES

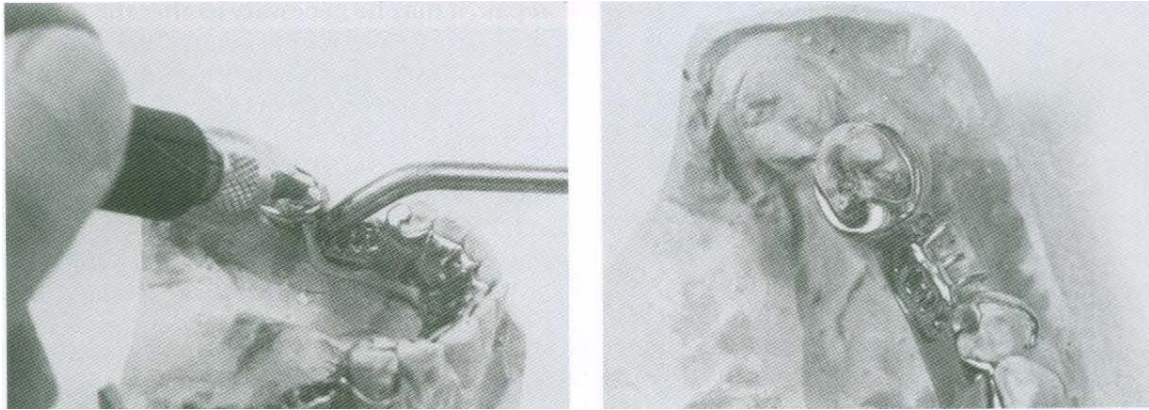
(**Figure-3-**) {**A:** Electrical soldering is used to repair rest. **B:** Rest is shaped to conform to rest seat outline. Framework is tried in patient's mouth for any necessary adjustment and rest is polished}.

An alternative solder to use is an industrial brazing alloy, which is higher fusing but responds excellently to electric soldering and does not tarnish, see (Figure-3-).

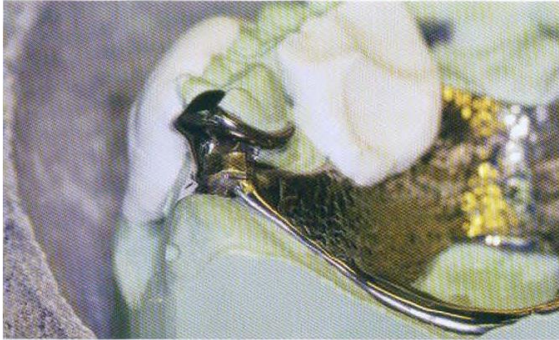
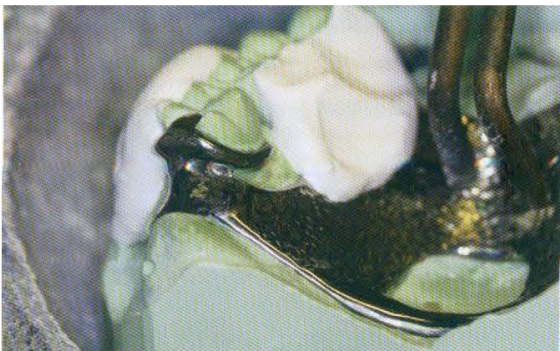
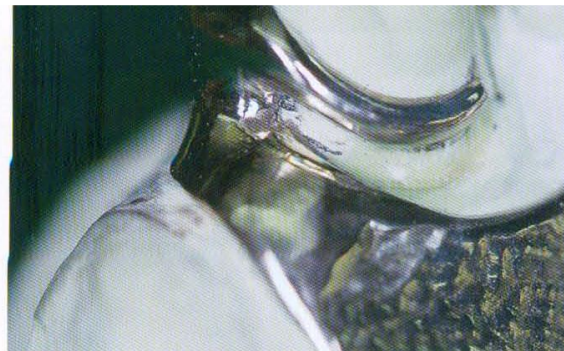
(Figure-4-){**A:** Maxillary juncture between major and minor connector at the distal of most posterior molar has fractured. Thin platinum foil has been adapted to the cast beneath the fracture, the clasp assembly has been stabilized on the cast with fast-set plaster, the remainder of the prosthesis has been positioned on the cast in full contact with teeth and tissues, and the solder has been positioned for the electric tip to be replaced. **B:** The electric soldering tip and ground are in place **C:** Immediately following solder flow, the fracture has been eliminated by the solder connecting the tow segments **D:** The polished solder repair is ready to be cleaned and returned to the patient. The patient is told that the repair is not as strong as the original and while it is difficult to know how long it could serve the patient, careful handling of the prosthesis is mandatory }.

weakening the restoration by attempting to compensate for its inadequacies by relieving the metal. Similarly, tissue impingement that arises from inadequately relieved components results from faulty planning, and the casting should be remade with enough relief to prevent impingement. Failure of any component that was weakened by adjustment at the time of initial placement is the responsibility of the dentist. Commonly, repeated adjustment to a major or minor connector results in a loss of rigidity to the point that the connector can no longer function effectively. In such situations, either a new restoration must be made or that part must be replaced by casting a new section and then reassembling the denture by soldering. The cost and probable success must then be weighed against the cost of a new restoration. Generally the new restoration is advisable, see (Figure-4-).
